DEPARTMENT OF TRANSPORTATION

Contract #: 04-0120F4Cty: SF/ALA Rte: 80 PM: 13.2/13.9File #: 1.28**WELDING INSPECTION REPORT****Resident Engineer:** Casey, William**Address:** 333 Burma Road**City:** Oakland, CA 94607**Report No:** WIR-028851**Date Inspected:** 10-Dec-2012**Project Name:** SAS Superstructure**OSM Arrival Time:** 700**Prime Contractor:** American Bridge/Fluor Enterprises, a JV**OSM Departure Time:** 1730**Contractor:** American Bridge/Fluor Enterprises, a JV**Location:** Job Site

Component: SAS Tower

Bridge No: 34-0006**Summary of Items Observed:**

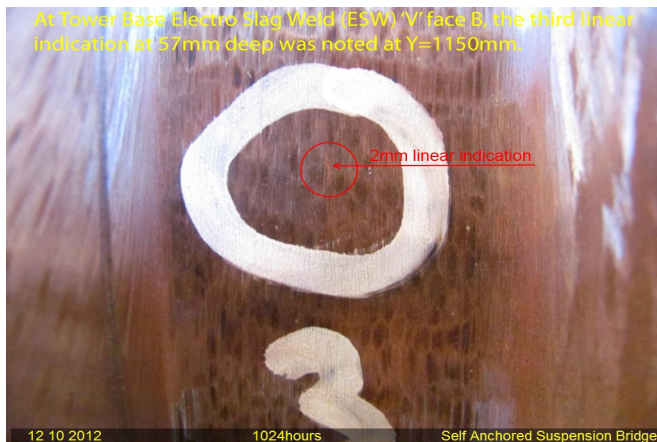
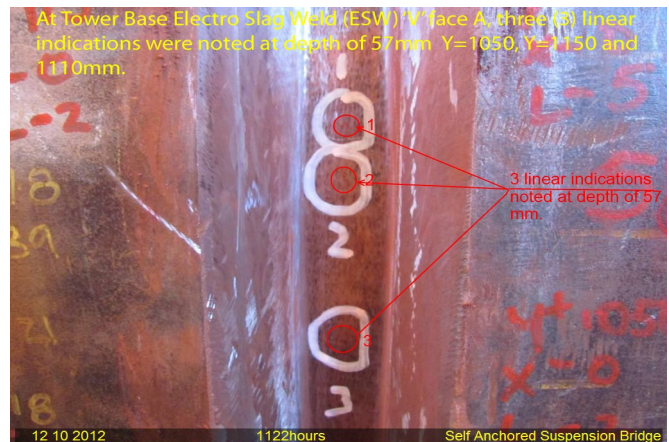
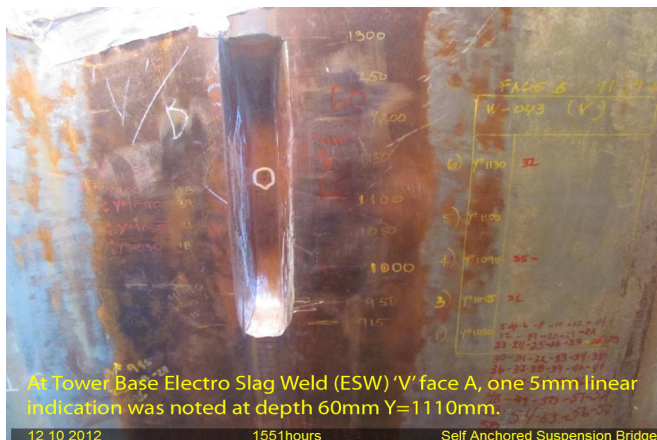
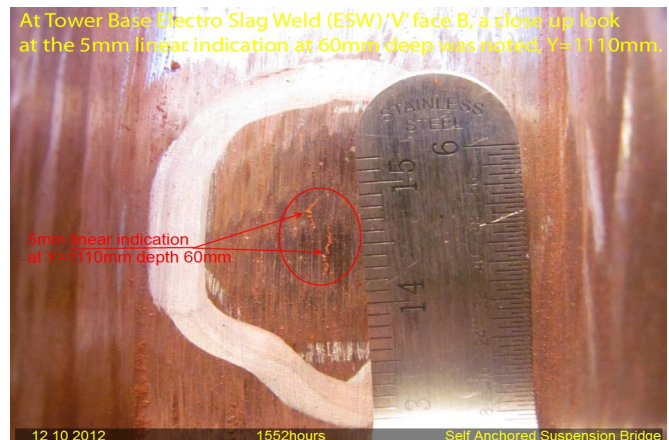
At Tower Base Electro Slag Weld (ESW) 'V' weld joint #W-043 face B, ABF personnel was observed continuing to perform exploratory excavation on welded ESW at various Y locations; Y=1030mm, Y=1055mm, Y=1090mm, Y=1100mm and Y=1130mm due to UT detected defects. The ABF personnel have resumed the exploratory excavation from 54mm deep where they left off Saturday. The personnel were noted using only the disc grinder in every 1mm increments of excavation. ABF QC Jesse Cayabyab was observed performing Magnetic Particle Testing (MT) on the following various depths with various indications noted mentioned below. This QA also performed the same test and noted same result. During the shift, the ABF personnel continued the excavation in 1mm increments using the same method of test and verification up to 60mm with indications as noted below. The shift was completed up to this depth of excavation.

1. 54mm in depth – no significant indication noted.
2. 55mm in depth –5mm linear indication noted @y=1110mm, X=0.

3. 56mm in depth – 5mm linear indication noted @y=1110mm, X=0; 2mm linear indication at Y=1050mm, X=0
4. 57mm in depth – 5mm linear indication noted @y=1110mm, X=0; 2mm linear indication at Y=1150mm, X=0; 2mm linear indication at Y=1050mm, X=0.
5. 58mm in depth – 5mm linear indication noted @y=1110mm, X=0; 2mm linear indication at Y=1150mm, X=0; 2mm linear indication at Y=1050mm, X=0.
6. 59mm in depth – 5mm linear indication noted @y=1110mm, X=0; the two (2) 2mm linear indications were removed.
7. 60mm in depth – 5mm linear indication noted @y=1110mm, X=0;

The exploratory excavations at this location will be continued on the following shift.
